## The Client

Two blocks of the most heavily used taxi-ways at the airport needed full repairs after 30 years of basic patch-repairs, due to the volume of use and the high cost of down-time. The airport authorities urgently needed an accurate, up-to-date picture of all underground features and services before breaking ground. This would prevent hazardous drilling work and eliminate surprises during remediation.

## Mobile GPR – Accurate and Safe Way to Scan

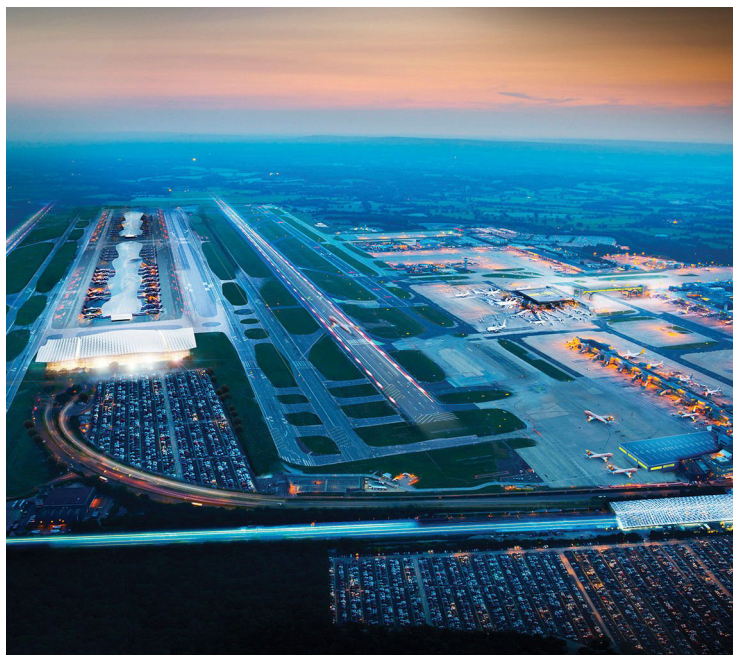
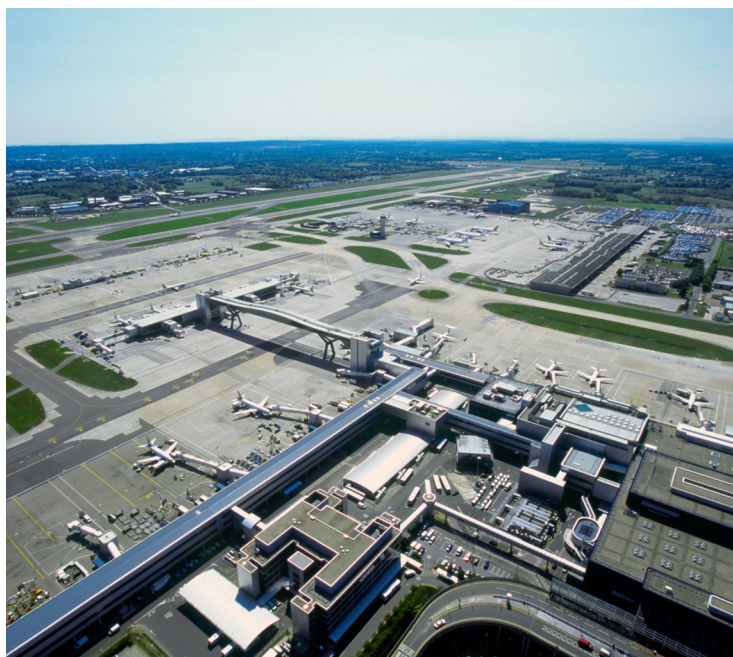
The scanning team carried out a BSI PAS:128:2014 - M4p utility survey. All data were positioned to Airport grid using GPS in open areas or Surveyor’s Total Stations in covered areas. Captured data were passed to the back-office for processing while site acquisition was still underway. The survey captured all detectable objects and features, including all airport ground lighting ducts, including some unknown from record information from previous taxiway alignments. This information is critical in locating and identifying potential hazards that may be encountered when drilling, excavating and re-surfacing on the airport. Avoiding utility strikes is a major requirement before any ground breaking takes place. The final deliverable to the project partner was a CAD model showing all detected objects and features with annotations and depths, along with accurate GPR data and images of the subsurface in a .jpg format.

Macleod Simmonds’ team combined leading-edge multi-channel GPR Stream array scanning technology with bespoke GPRCAD software to provide a PAS:128 compliant survey to the maximum possible quality. As the taxi-way had to be scanned with minimum disruption, the vehicle-towed Stream EM was used for the most part to cover the largest areas, and the hand-pushed Stream C and 24 Channel HDAGPR were used to infill any remaining gaps caused by poor access to the survey area.
